Manhole Inspection Summary

Manhole # S41U__021MH

Insp Date: **10/13/08 9:01 AM**

Location Address: **1465 key hw**

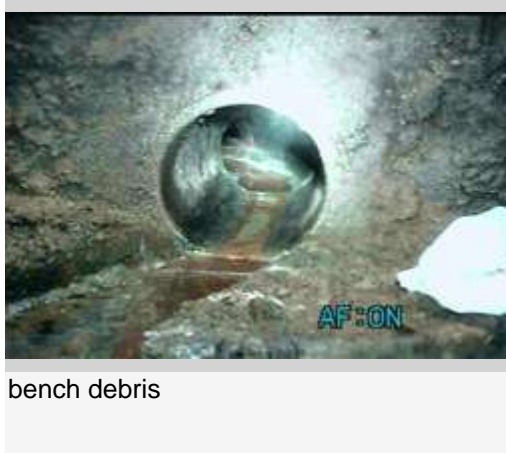
Defect 3

Condition: ☐ Sound ☐ Cracked ☐ Root Intrusion ☐ Deteriorated ☐ Leaks ☒ **Debris**

bench debris

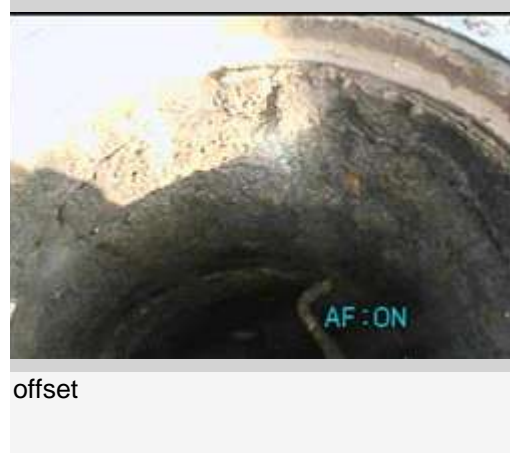
Defect 2

Offset: **2.5** (in.)

offset

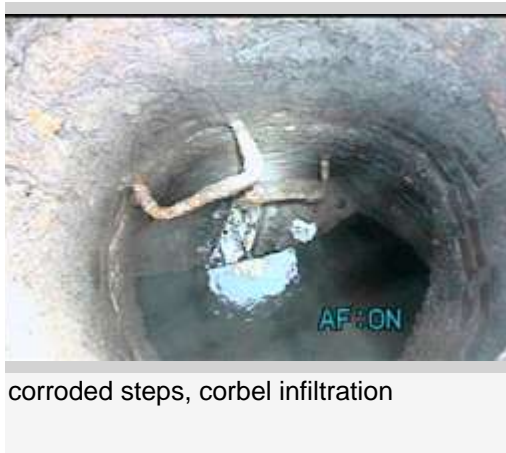
Defect 1

Infiltration: ☐ None ☒ **Joint** ☐ Cracks ☐ Mortar ☐ Roots ☒ **Wall**

Count: **2** Missing: **0** ☒ **Corroded**

corroded steps, corbel infiltration

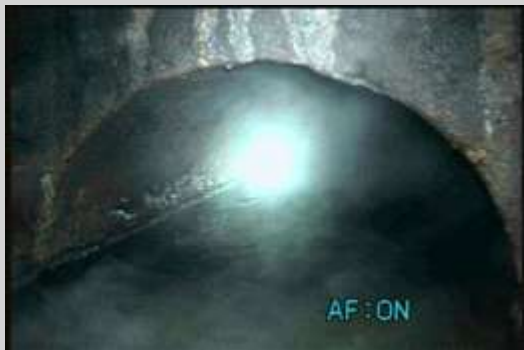
12 O'Clock Outflow

30 in. Circular Gravity Sewer
Pipe Out @ 12 O'Clock

Pipe Material: **Clay** ☐ Pipe Lined

Invert Depth: **6.75** (ft.) Flow Characteristics: **Fast**

Infiltration: **None** Pipe Seal Cond: **Unknown**

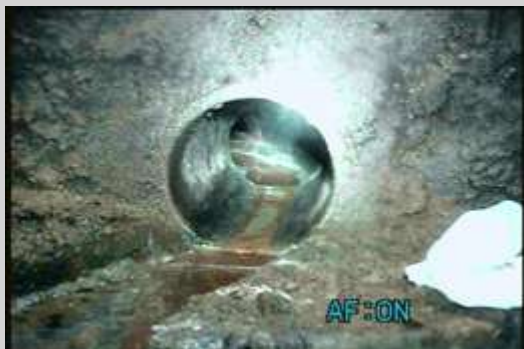
3 O'Clock Inflow

6 in. Circular Gravity Sewer
Pipe In @ 3 O'Clock

Pipe Material: **Clay** ☐ Pipe Lined

Invert Depth: **5.63** (ft.) Flow Characteristics: **Fast**

Infiltration: **None** Pipe Seal Cond: **Unknown**

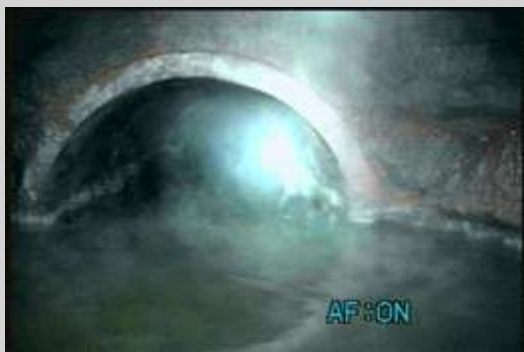
7 O'Clock Inflow

18 in. Circular Gravity Sewer

Pipe In @ 7 O'Clock

Invert Depth: **6.63** (ft.) Flow Characteristics: **Fast**

Infiltration: **None** Pipe Seal Cond: **Unknown**
